Dor End of Season 2005 Area D1 East Supervisor's Report

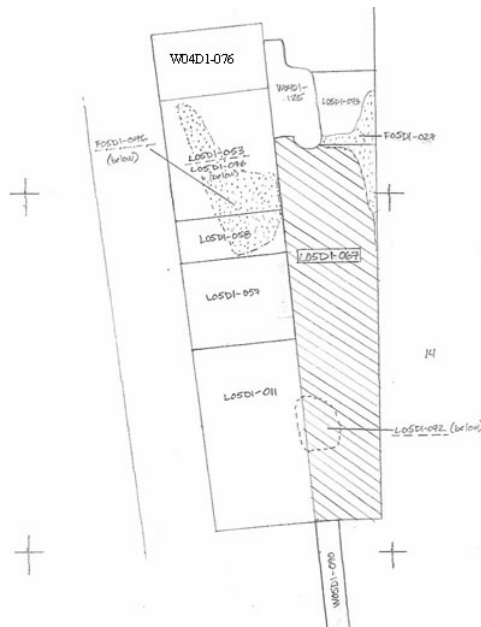
In AQ-13/14/15 a few new Phase 2 features were found.

Between the two main robber trenches was a small area with the only undisturbed loci including L05D1-010 and (below it) W05D1-028, L05D1-052 and L05D1-057. This is the same area that contained the isolated sequence of Phase 0-2 floors in the 2004 season (F04D1-014, F04D1-086, F04D1-098). At the end of the season, it revealed a

portion of a well-preserved, thick plaster floor F05D1-076 (#14.63-14.55; P05D1-9075, -9085). The floor is cut by Phase 1 possible pit L05D1-126 and nearly reaches Phase 2 W04D1-175 (that dovetails with W04D1-125). Eastern robbing trench L05D1-027 came down on a substantial plaster floor, F05D1-027 (#14.87-14.68), on which the Phase 1-2 W04D1-125 sits (P05D1-0979, D05D1-1805). F05D1-027 was assigned tentatively to this phase because its elevations are similar to those F05D1-076.

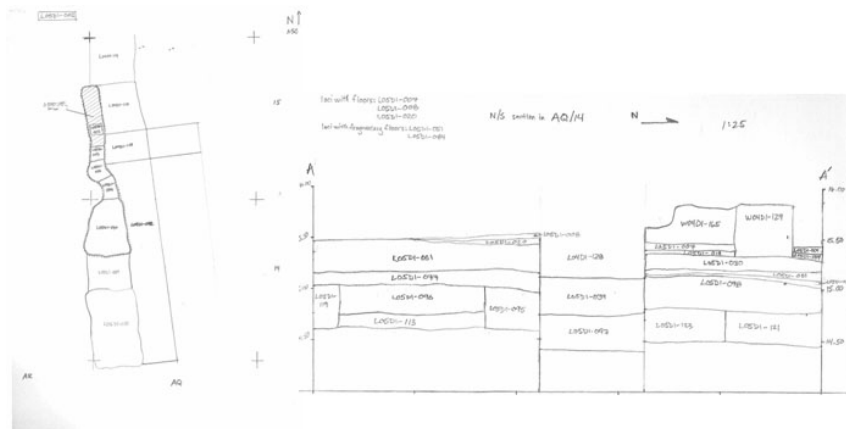
The most important feature in this area is the “floor sandwich”, most of which was sealed by Phase 2 walls and floors (see report from 2004). These walls and floors were all removed, from North to South: W04D1-094, W04D1-136, F04D1-147, W04D1-127, W04D1-165, F04D1-129, F04D1-164, W04D1-185. All features and the “sandwich” were cut by a British Trench (L04D1-128 = L05D1-039 = L05D1-097):

The formation of the “sandwich” is not altogether clear. In areas we found what we thought were certain floors, but the section showed that some of these may have been accumulations (see the micromorphology report). Both the northern and southern portions of the upper “sandwich” have good loci with the latest pottery dating to the early Roman (with Type 12 lamps, “Megarian” bowls and Eastern Terra Sigillata) before moving into loci with early/mid Hellenistic and Persian pottery. Although many of the loci within the sandwich are technically unsealed, they are still good contexts with the exception of the latest, southernmost portion, L05D1-119, that appears to be disturbed. Based solely on the pottery reading, the Phase 2 floors within

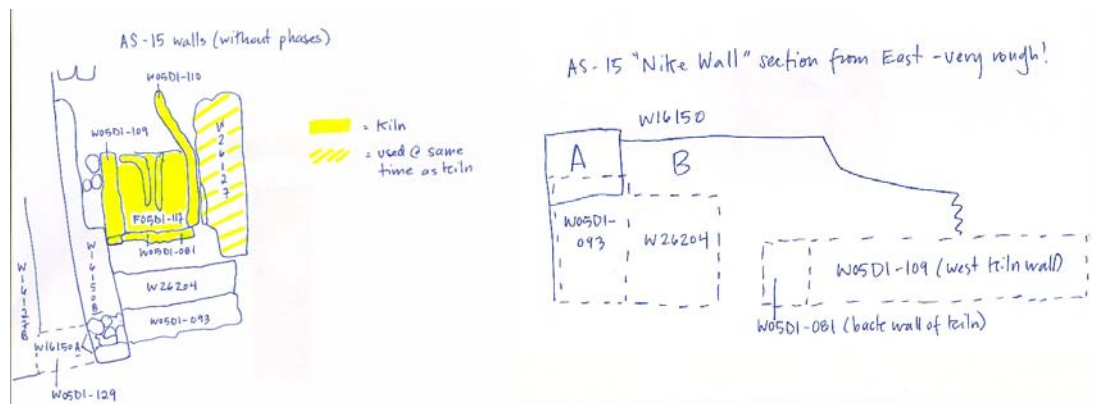
Phase 2b contains the kiln:

Side walls W05D1-109 and W05D1-110 abut back wall W05D1-081; as preserved, the firebox floor F05D1-117 reaches only the two side walls -109 and -110. Eastern kiln W05D1-110 is built against W26127. W26127 is 2b based on its construction technique (at least one reused column drum) and signs of burning that show it was contemporary with the kiln. Then 2b is:
